MICROSCOPIC EXAMINATION OF STEEL

HENRY FAY, Ph. D., D. Sc.

*Professor of Analytical Chemistry, Massachusetts Institute of Technology
Consulting Metallurgist, Watertown Arsenal*

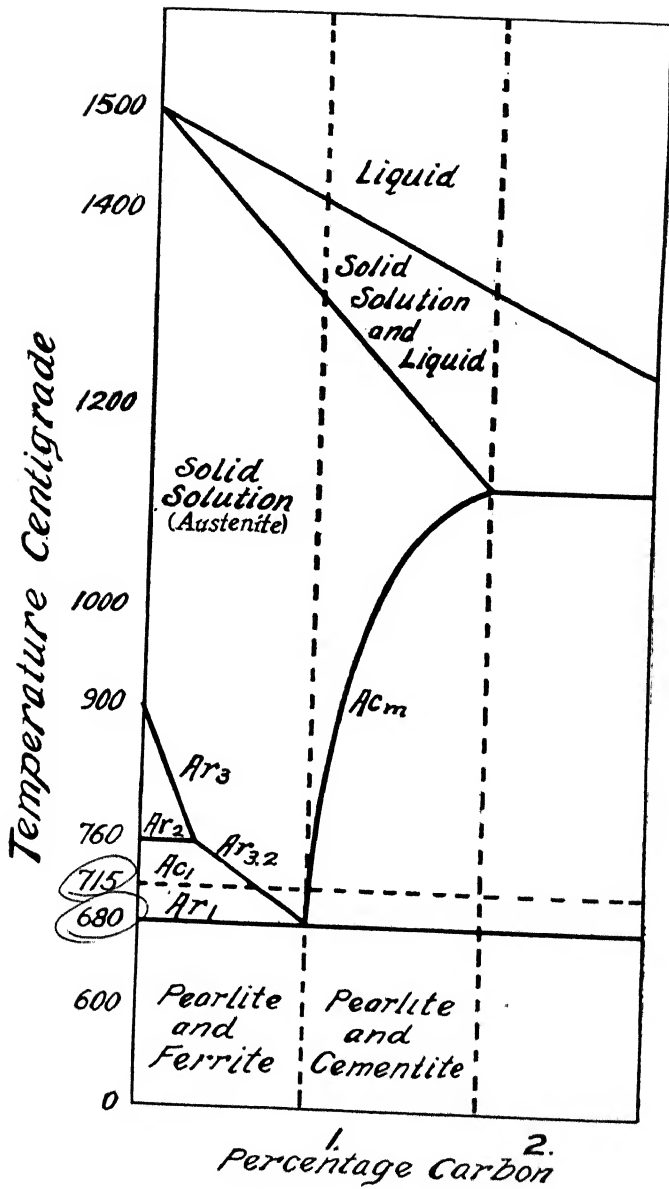
Fig. 1

Portion of iron-carbon diagram

constituents, iron and iron carbide. The A_{c1} point is approximately 30° higher than the A_{r1} point, and represents the beginning of the formation of solid solution. In steels containing 0.85 per cent carbon there is but one critical temperature at which the solid solution decomposes into its constituents, iron and iron carbide. This is known as an eutectoid steel, and its microscopic constituent is pearlite. Pearlite always etches dark, and under high magnifications is shown to consist of alternate laminations of iron and iron carbide. Steels containing less than 0.85 per cent carbon are hypoeutectoid, and contain the microscopic constituents ferrite and pearlite, the amount of the latter increasing with the per cent of carbon. Steels containing more than 0.85 per cent carbon are hypereutectoid, and contain the microscopic constituents cementite (iron carbide, Fe_3C) and pearlite. These facts are illustrated in the diagram. (Fig. 1.)

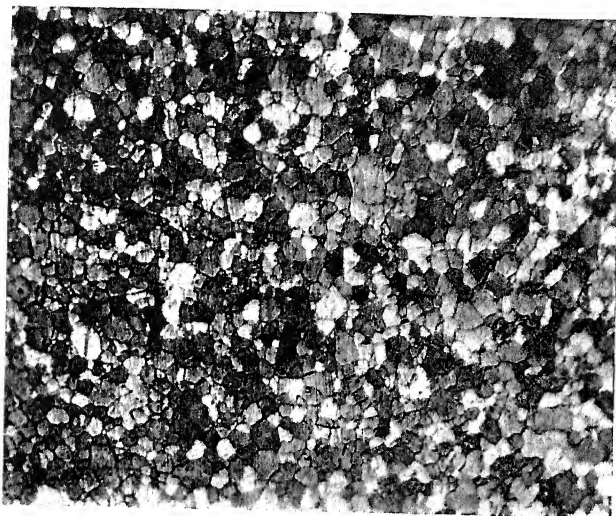
PHOTOGRAPH NO. 1. X75.
0.06% carbon. Approximately pure ferrite.

Photograph No. 1 shows the characteristics of a carbonless iron in which the whole field is made up of granules of ferrite. With the introduction of carbon there is a decrease in the amount of ferrite and the constituent pearlite begins to appear. This is shown in photograph No. 2 for a steel containing 0.18 per cent carbon. Inasmuch as steels containing 0.85 per cent carbon contain 100 per cent pearlite, and as pearlite is composed of ferrite and cementite, in this steel containing 0.18 per cent carbon there ought to be approximately 20 per cent of the field made up of pearlite. In a steel containing 0.5 per cent carbon there should be 58.8 per cent pearlite. Such a steel is shown in photograph No. 4. A eutectoid steel containing 0.83 per cent carbon and practically 100 per cent pearlite is shown in photograph No. 7. Under higher magnifications pearlite shows the laminated structure shown in photograph No. 8. In hypereutectoid steels the excess carbon beyond that necessary to form pearlite, separates as free cementite and the amount of free cementite can be calculated. Inasmuch as the whole field is made up of pearlite

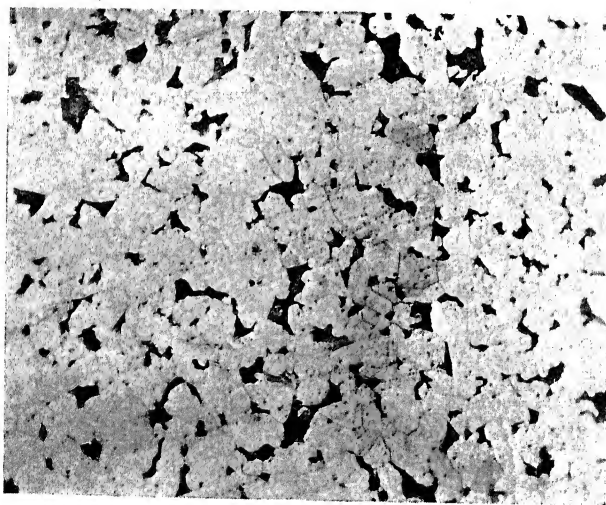
PHOTOGRAPH NO. 2. X75.
0.18% carbon. Ferrite (white) and pearlite (dark).

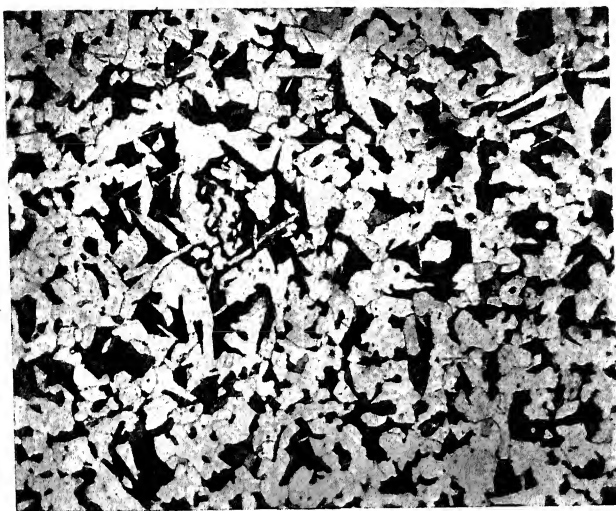
PHOTOGRAPH NO. 3. X75.

0.32% carbon. Ferrite (white) and pearlite (dark).

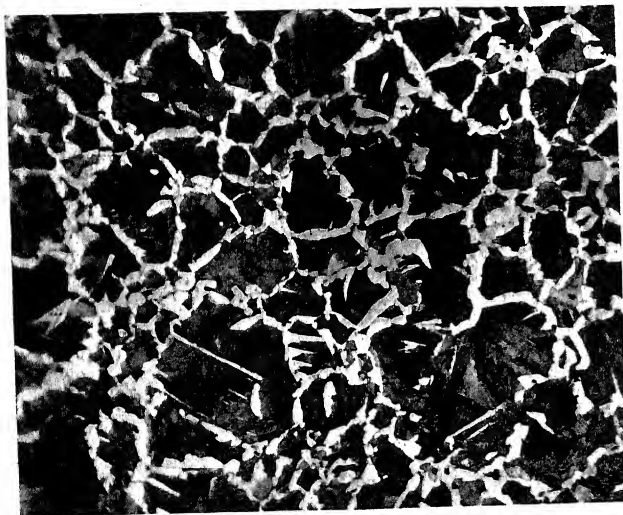
PHOTOGRAPH NO. 4. X75.

0.49% carbon. Ferrite (white) and pearlite (dark).

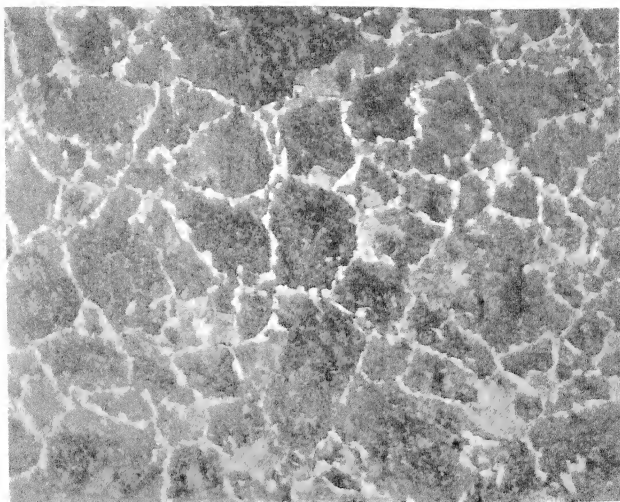
PHOTOGRAPH NO. 5. X75.
0.57% carbon. Ferrite and pearlite.

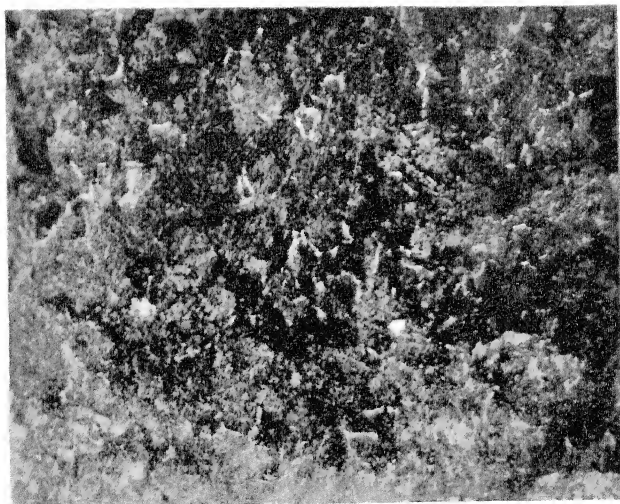
PHOTOGRAPH NO. 6. X75.
0.71% carbon. Ferrite and pearlite.

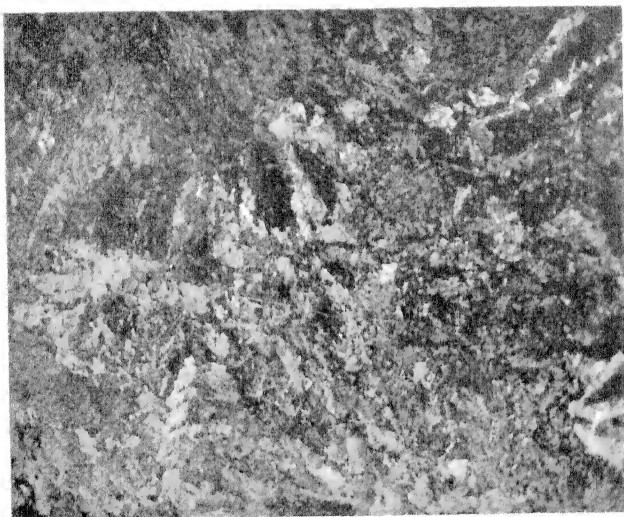
PHOTOGRAPH NO. 7. X75.

0.83% carbon. Pearlite.

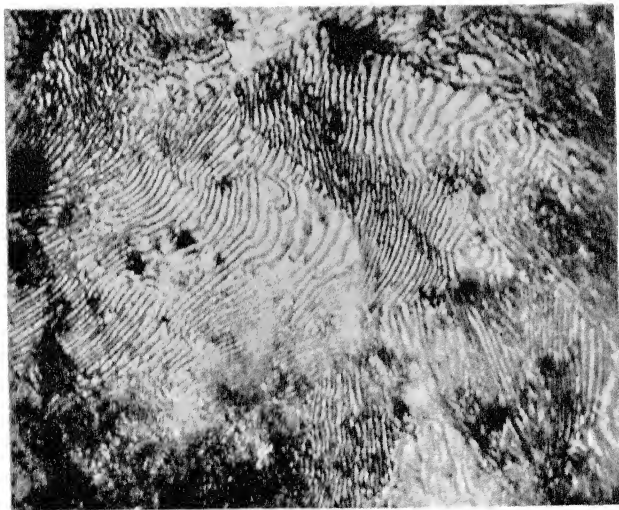
PHOTOGRAPH NO. 8. X485.

0.83% carbon. Pearlite.

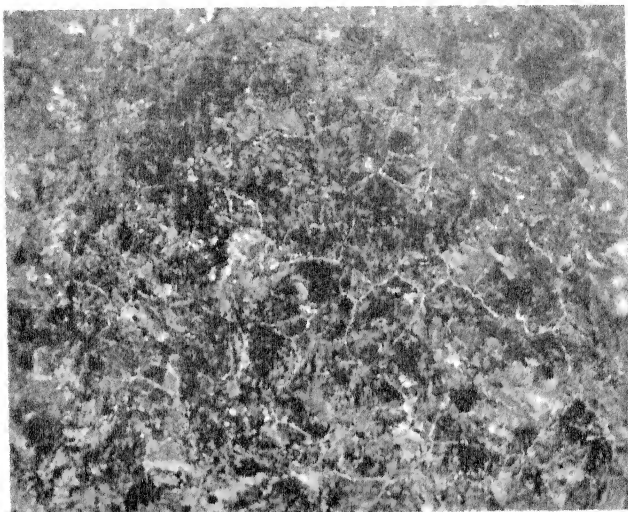
PHOTOGRAPH NO. 9. X75.

1.22% carbon. Pearlite and cementite (white).

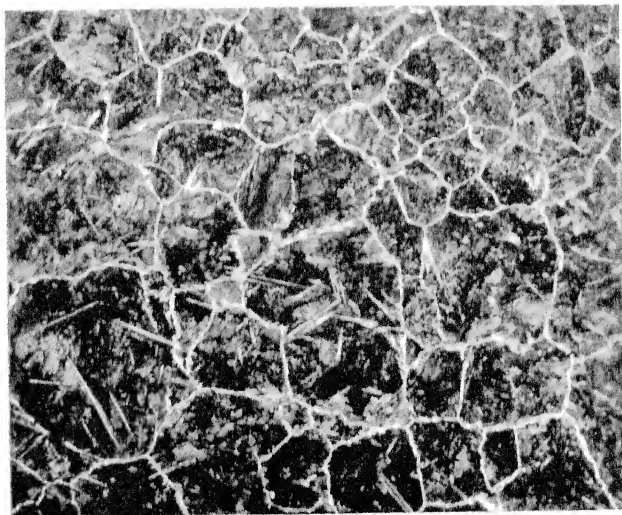
PHOTOGRAPH NO. 10. X75.

1.46% carbon. Pearlite and cementite (white).

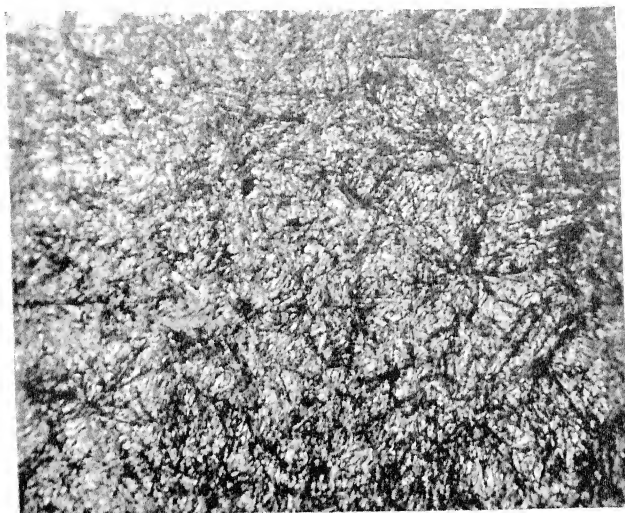
PHOTOGRAPH NO. 11. X75.
Martensite.

Photograph No. 11 shows the characteristic appearance. Commercially martensitic steels are unimportant on account of their extreme brittleness and they are found only rarely.

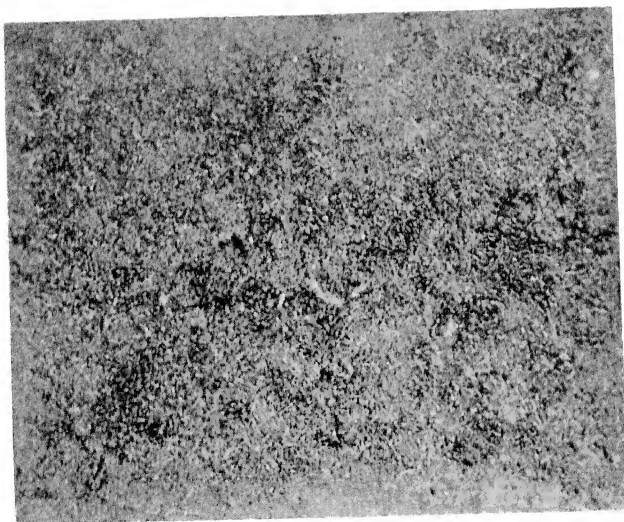
PHOTOGRAPH NO. 12. X75.
Troostite.

If heated to temperatures below A_{c1} , the effect produced will vary with the temperature. The lower the temperature of reheating the smaller is the tendency toward stable equilibrium; the higher the temperature the more stable is the product produced. Practically any degree of hardness may be produced, varying from glass-hard to extreme softness, by properly regulating the temperature of the heating. There are then two extremes, the martensitic steels formed by quenching from above A_{c1} and the pearlitic steels formed by cooling slowly from A_{r1} or above. Intermediate between these extremes are steels in which more or less of the unstable solid solution has been partly converted to more stable forms. Such forms are represented microscopically by troostite and sorbite. Troostite, formed by tempering at relatively low temperatures, represents the first stage in the breaking down of the unstable equilibrium and is characterized by the amorphous or slightly granular structure. On etching with alcoholic nitric acid the surface usually blackens immediately from separated carbon. Photograph No. 12 shows troostite.

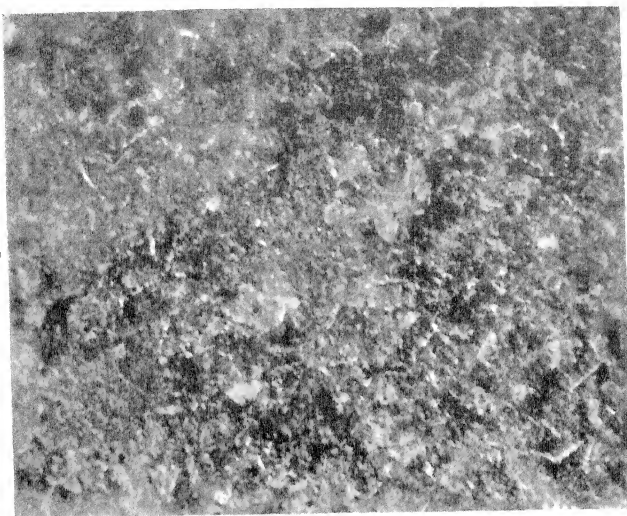
PHOTOGRAPH NO. 13. X75.
Sorbite.

Sorbite steels are those which have been quenched and heated to a higher temperature and thus represent a more stable state of equilibrium. They are characterized by having a peculiar grayish color, and the structure is better defined than troostite. The particles of iron carbide have not assumed definite laminations with ferrite as in pearlite, but are very much more distinct than in troostite. Photograph No. 13 shows sorbite.

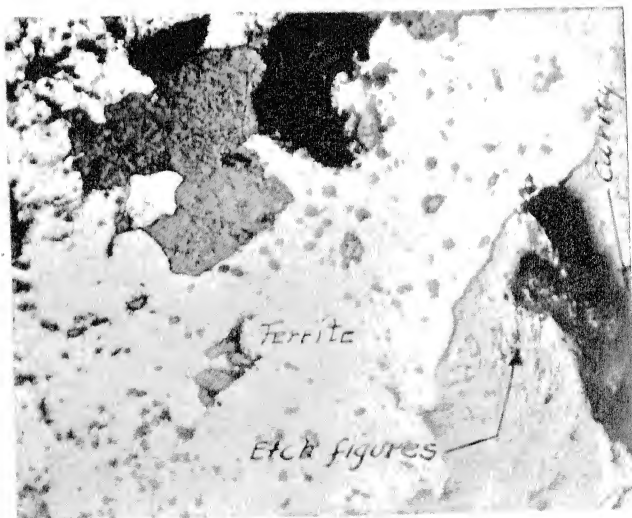
PHOTOGRAPH NO. 14. X50.
Ferrite and massive silicate of manganese. Etch figures in the silicate. (Ferrite, white; silicate, dark.)

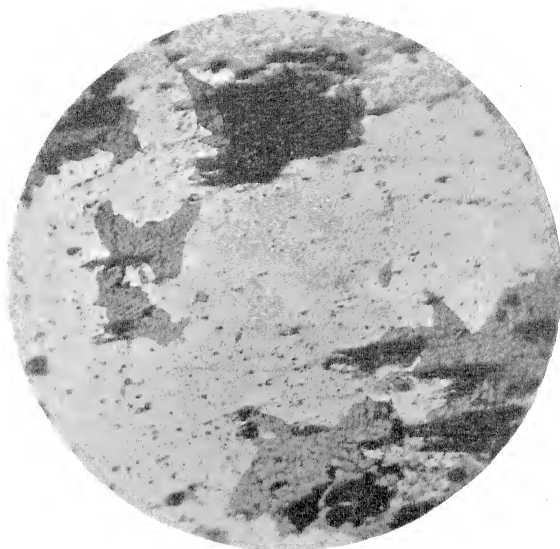
PHOTOGRAPH NO. 15. X50.

Etch figures in silicate of manganese, and cavities due to removal of silicate.

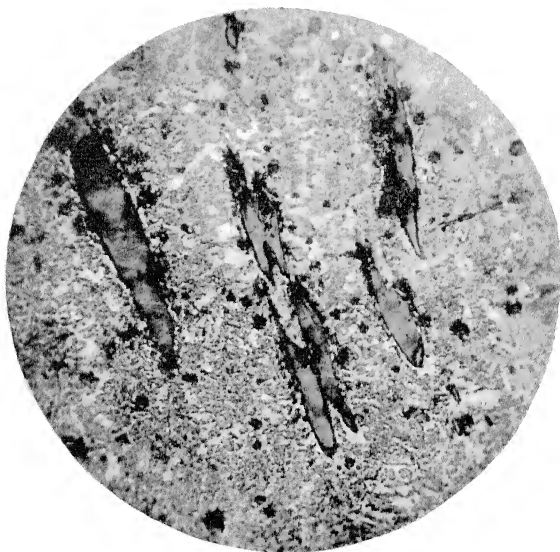
PHOTOGRAPH NO. 16. X50.

Sulphide of manganese in gun steel.

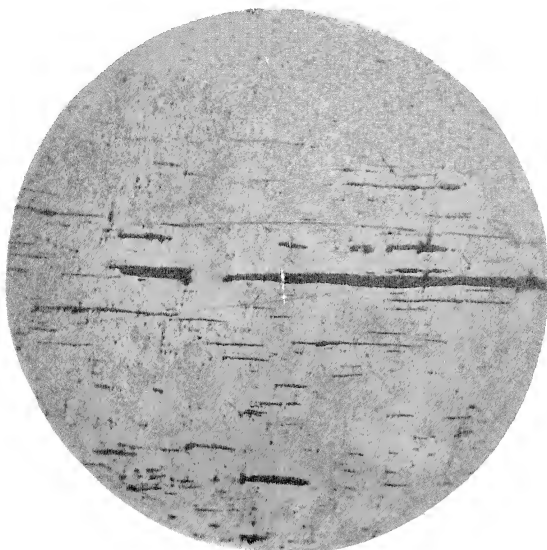
PHOTOGRAPH NO. 17. X50.

Slag elongated in direction of forging. Specimen unetched.

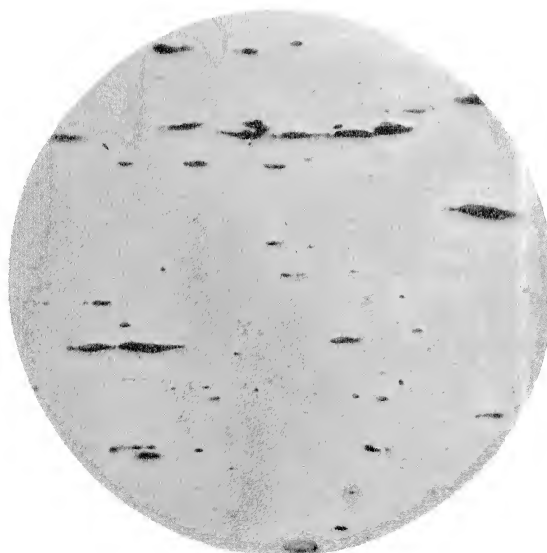
PHOTOGRAPH NO. 18. X50.

Unevenly distributed slag. Specimen unetched.

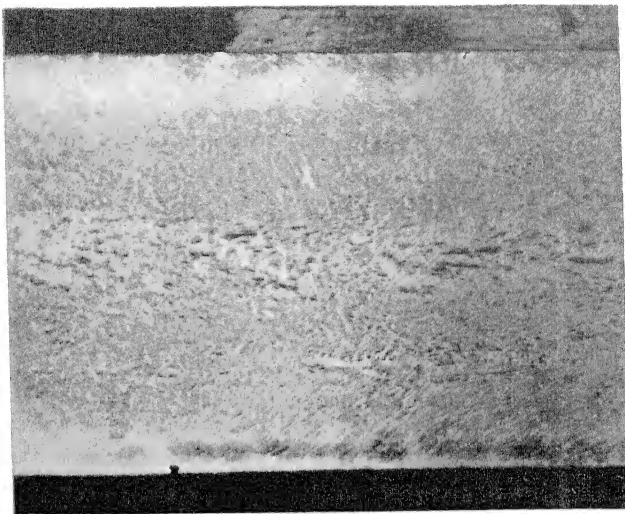
PHOTOGRAPH NO. 19. ONE-THIRD SIZE.
Ingot structure in steel.

The presence of ingot structure such as shown in photograph No. 19 indicates that the heat treatment and forging have not been sufficient to wipe out the crystallization which occurred on the solidification of the metal. It is not definitely known that the presence of ingot structure is harmful, and it is frequently accompanied by excellent microstructure, but it serves as an indication of the heat treatment to which the metal has been subjected after solidification. It is believed that such a structure would not be found in the best steel, and it is further believed that metal showing ingot structure would be more liable to rupture from shock than metal in which the ingot structure had been wiped out by heat treatment and forging.

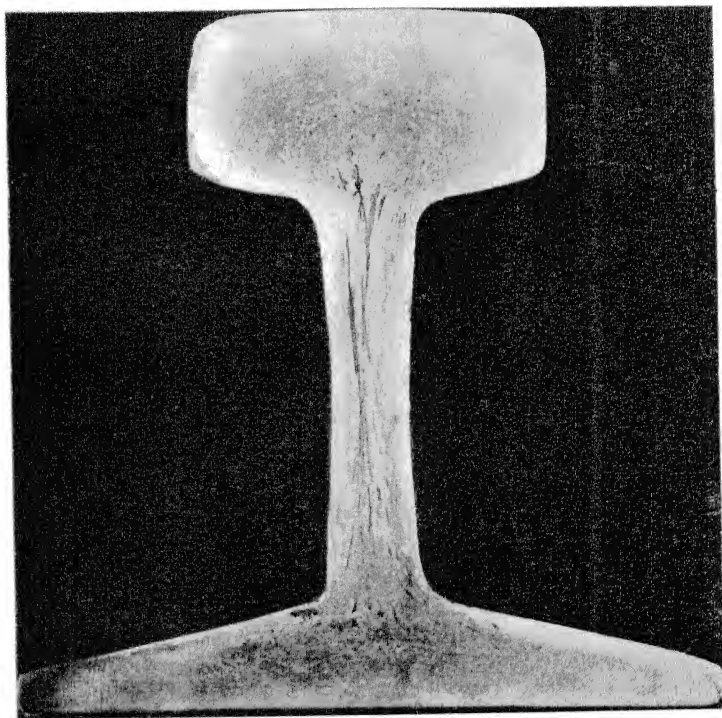
PHOTOGRAPH NO. 20.
Cross section of steel rail showing segregation in center of head, web, and base.

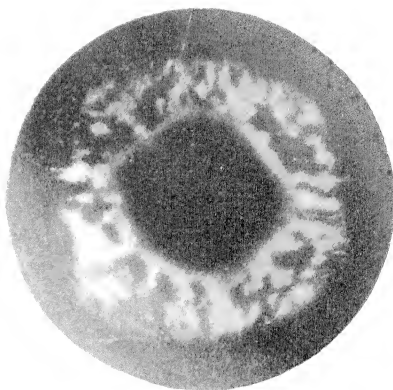
PHOTOGRAPH NO. 21.

Segregation of phosphorus in cold-rolled shafting.
Etched with iodine. (White areas.)

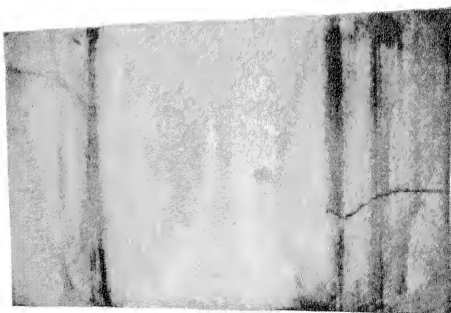
PHOTOGRAPH NO. 22.

Cross section of No. 21. Etched with nitric acid.
(Dark streaks.)

in which segregation of phosphorus is shown. Photograph No. 22 shows a longitudinal section of the same piece of shafting and is etched with nitric acid, which darkens the phosphide areas. It is seldom possible, however, to obtain complete cross sections, but valuable indications may be obtained from surface structures or from test-bar sections, such as shown in photograph No. 38 of test bars marked 2, 3, and 5. The phenomena observed here will be more fully discussed later.

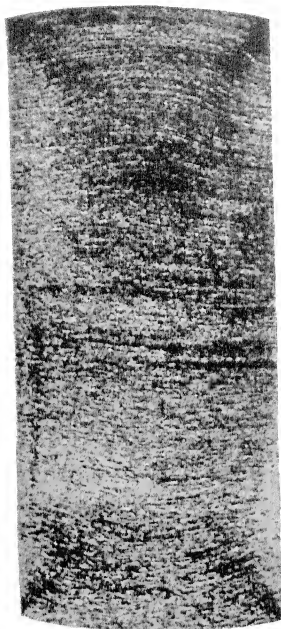
PHOTOGRAPH NO. 23.

Area of strained metal brought out by etching with copper ammonium chloride.

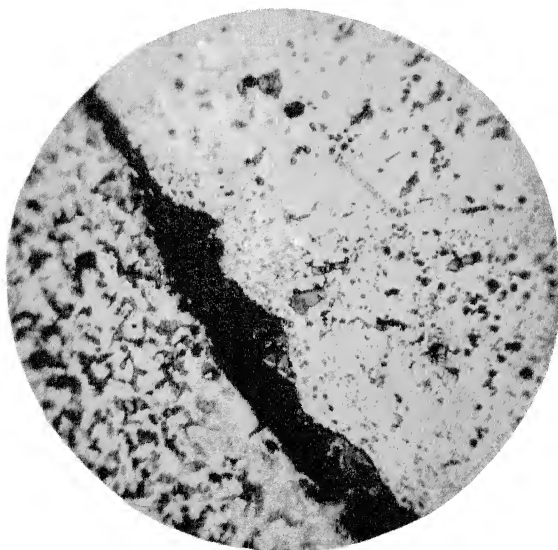
PHOTOGRAPH NO. 24. X50.

Crack, slag, and decarbonized area found on the base of a steel rail.

The inclusion of oxide is frequently accompanied by partial decarbonization, and is most frequently found on or near the surface. An example of this is shown in photograph No. 24, in which it is seen that a crack has penetrated through the slag, probably mill scale, and in the crack are the remnants of the slag. On the left of the crack is the normal structure and on the right is a decarbonized area containing slag. Such an area would probably be large enough to show to the naked eye and would be considered unsafe. Other examples of oxide inclosures are cited on pages 14 and 15, in the discussion of the failure of 10-inch gun and 14-inch gun lever.

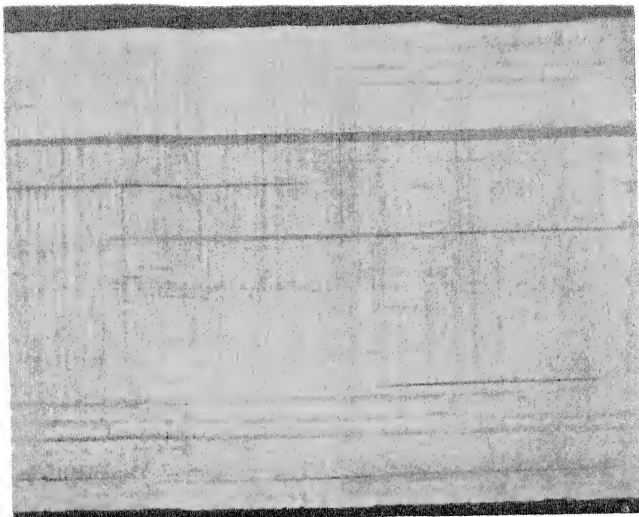
PHOTOGRAPH NO. 25.
Dark streaks in steel rail.

Radial test pieces from gun forgings will frequently show streaks, and as the tension is normal to the direction of extension the specimen will show low ductility. Photographs Nos. 25 and 26 show, respectively, dark and light streaks, and photograph No. 27 shows the microstructure of a portion of the light-colored streak with its decarbonization and accompanying slag. (See also Tests of Metals for 1909, vol. 11.)

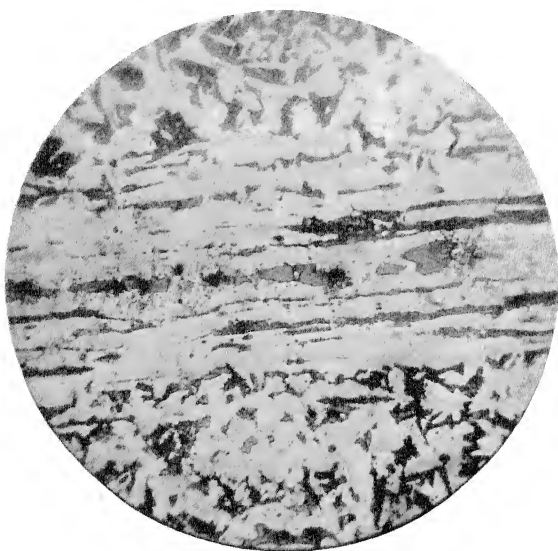
PHOTOGRAPH NO. 27. X50.

Microstructure of light-colored streak in No. 26.

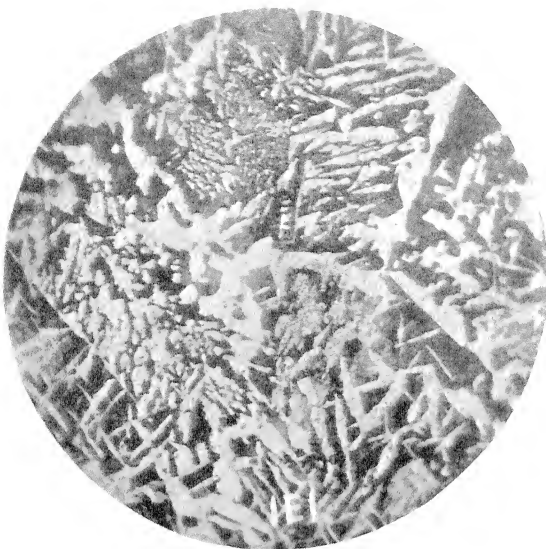
PHOTOGRAPH NO. 28. X75.

Microstructure of cast steel ingot as cast.

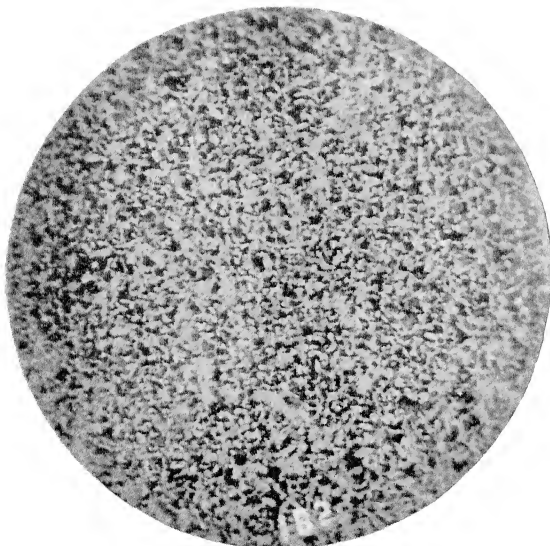
PHOTOGRAPH NO. 29. X75.

Microstructure of cast steel ingot forged to 1450° F. (788° C.)

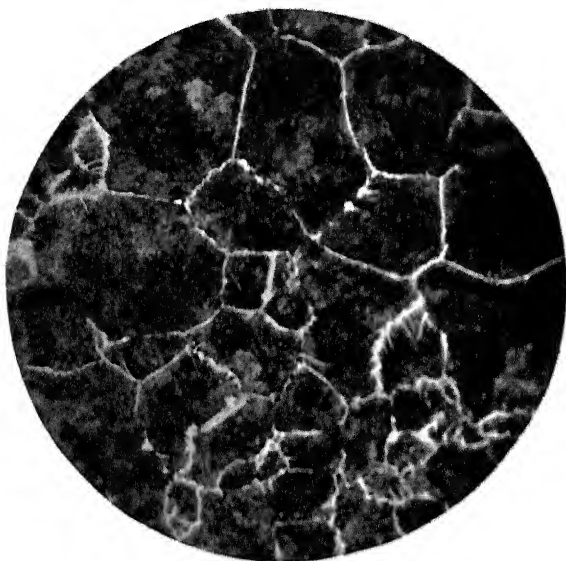
PHOTOGRAPH NO. 30. X75.
Coarse microstructure in gun steel.

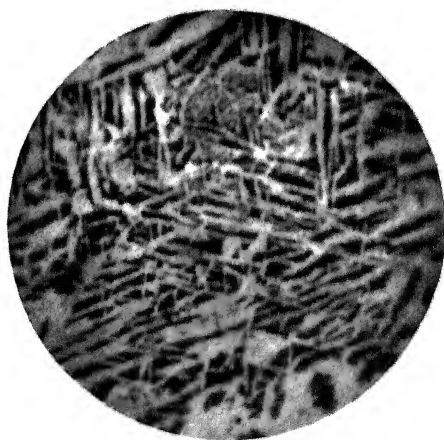
PHOTOGRAPH NO. 31. X50.
Crystalline structure in cast steel.

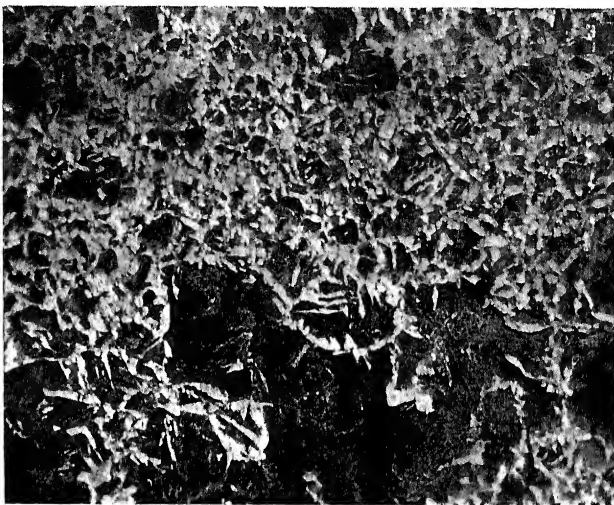
PHOTOGRAPH NO. 32. X75.

Microstructure showing incomplete heat treatment.

Failure to obtain uniformity of structure is shown in photograph No. 32. Discussion of photographs Nos. 49, 51, and 53 will be found under the discussion of some of the special cases, viz., the failure of 14-inch gun lever arm. Dangerous overheating is shown in photograph No. 33. In this case the material is burnt, as is shown by the oxide between the granules of pearlite.

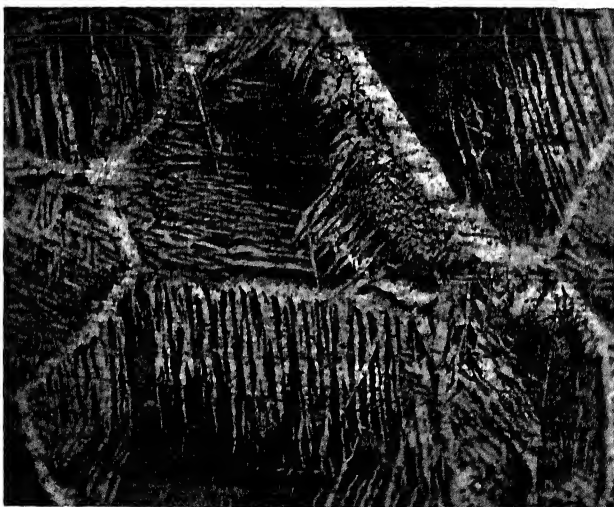
PHOTOGRAPH NO. 33. X75.

Microstructure of overheated steel.

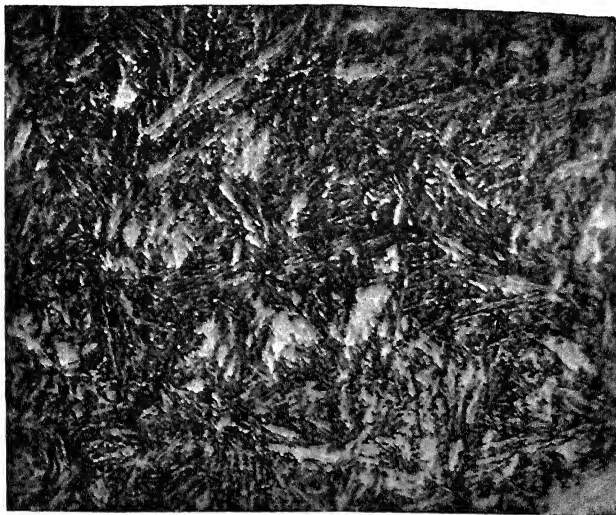
PHOTOGRAPH NO. 34. X500.

Microstructure of forging which had been originally martensitic, and in tempering this structure has not been completely eliminated.

observed that the original martensitic structure is completely removed by the tempering process. This point is illustrated by photograph No. 34 in which there are distinct remains of the original martensitic structure. Such a steel properly heat treated ought to show a structure similar to photographs Nos. 12 or 13.

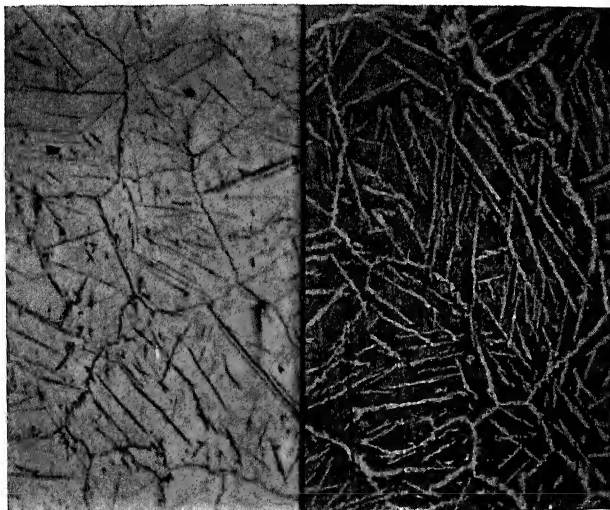
PHOTOGRAPH NO. 35. X65.

Microstructure in center of broken recoil spring showing excess cementite, indicating high carbon. Left, white lines are cementite etched with nitric acid solution; right, dark lines are cementite etched with sodium picrate solution.

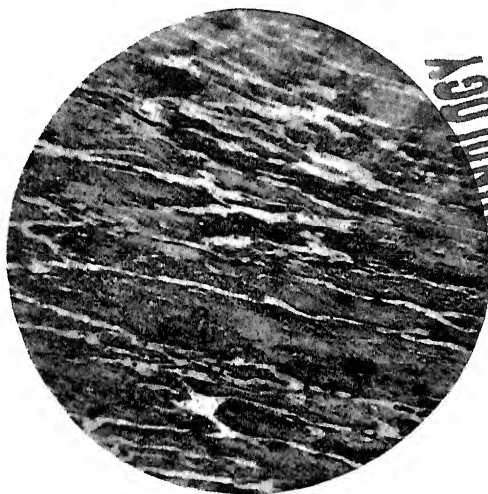
PHOTOGRAPH NO. 36. X50.

Microstructure of steel subjected to cold work, and
showing distortion of grain.

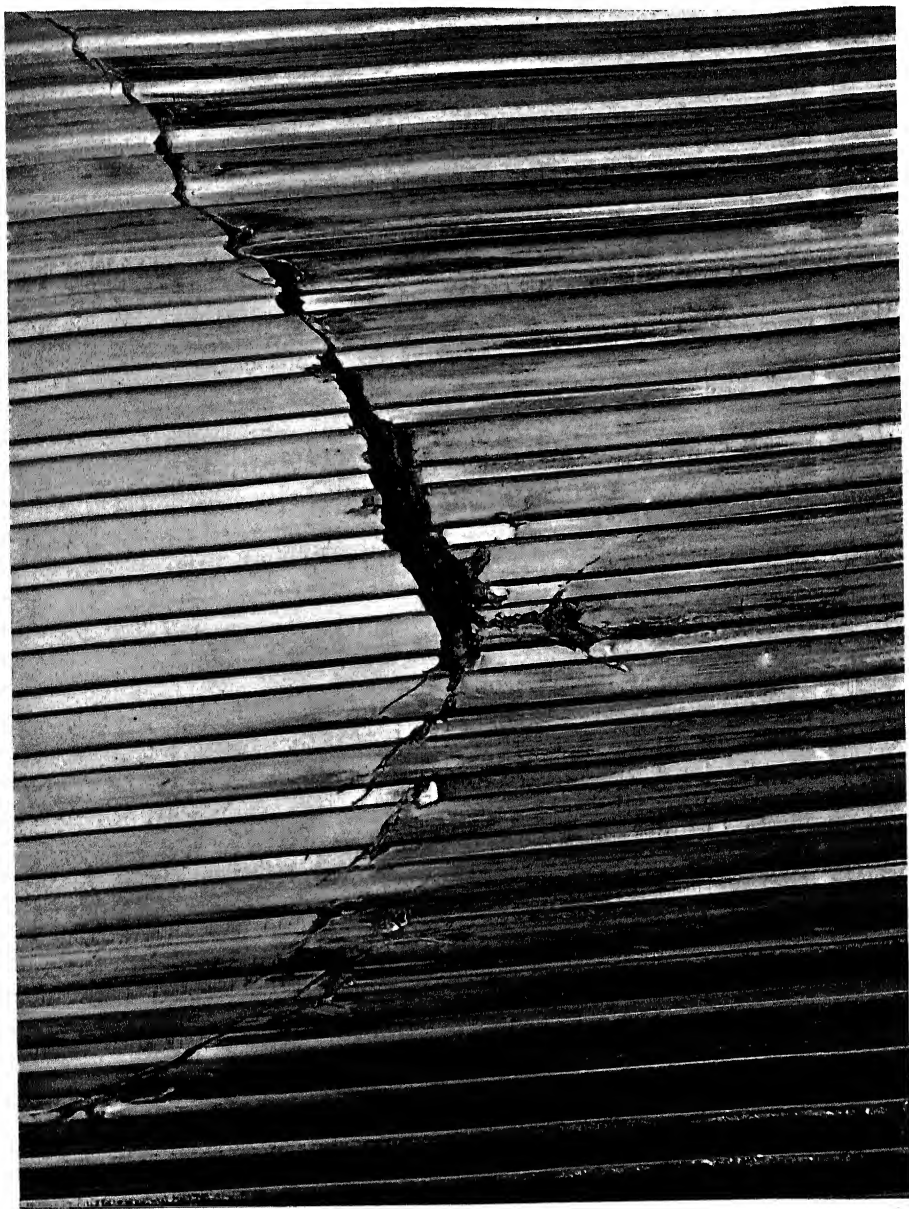
PHOTOGRAPH NO. 37.
Crack in 10-inch rifle.

The tube of this gun was found to be cracked after proof-firing. The crack was situated about 2 feet in from the breech end and extended in the form of a crescent through a visible distance of about 10 inches. At the central portion of the crack the walls were considerably more separated than at either end, and considerable metal had been removed at this point. The general appearance is shown in photograph No. 37. It will be noted that the crack is not continuous.

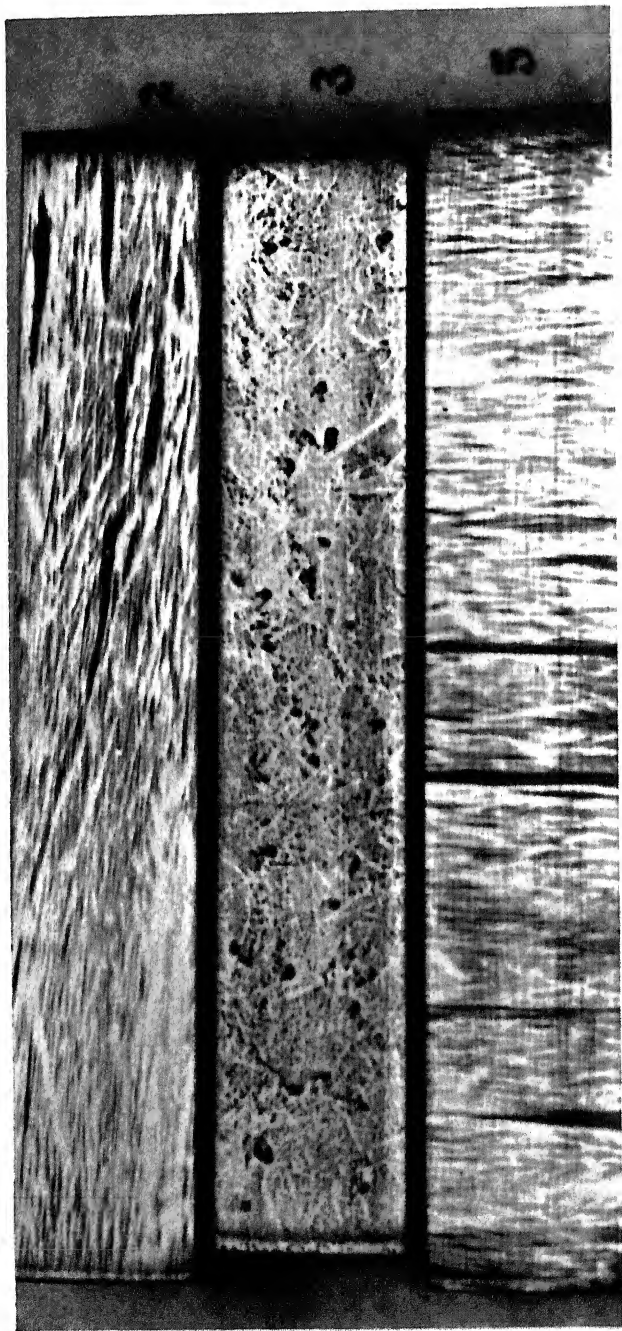
PHOTOGRAPH NO. 38.

Macrostructure of test bars of 10-inch rifle, showing surfaces cut longitudinal 5, radial 3, and tangential 2 to axis.

Photographs Nos. 38 and 39 show the macrostructure of this steel when etched with iodine, the specimens shown in photograph No. 38 being taken longitudinally, radially, and tangentially. The segregation of phosphorus is indicated by the dark lines in pieces Nos. 2 and 5 of photograph No. 38 and in both pieces of photograph No. 39 and by the dark spots in piece No. 3. Photograph No. 39 shows the metal cut from the region of the fracture and treated in the same manner, as shown in test piece marked 5 in photograph No. 38, and in other test pieces not shown. The dark streaks were found to be elongated parallel to the direction of forging, and it is reasonable to suppose that the elongation will always be parallel to the surfaces being forged. By inspection of the two larger pieces of metal cut from the region of the crack (photograph No. 39) it will be seen that there is considerable distortion of the phosphide areas near the

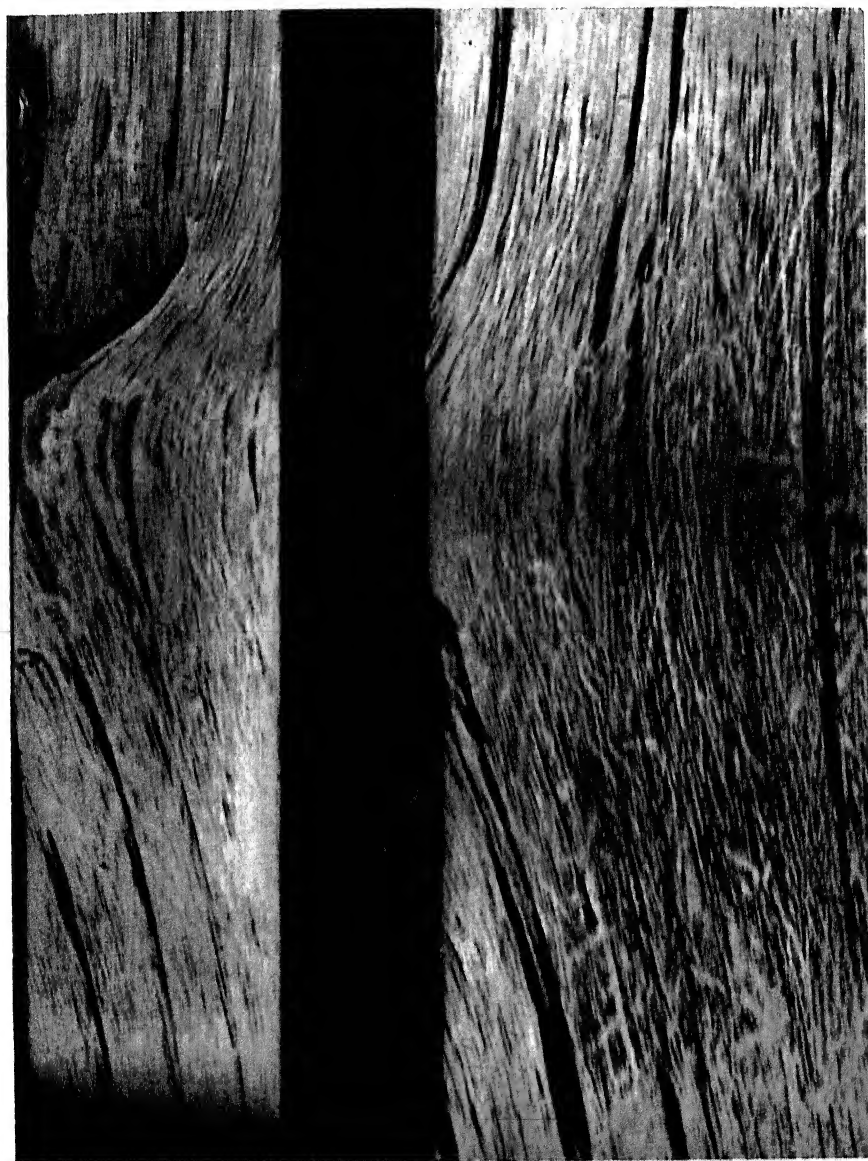
PHOTOGRAPH NO. 39.

Macrostructure in region of crack in 10-inch rifle.

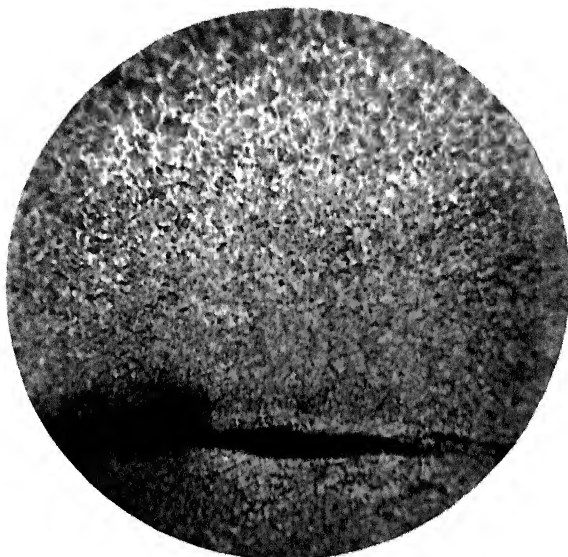
PHOTOGRAPH NO. 40. X50.

Crack and slag, with decarbonized area in 10-inch rifle.

Examination of sections in the vicinity of the crack showed many fine cracks, slag inclusions, and carbonless areas. The cracks led to slag, and where the slag was found there were also found decarbonized areas. Photograph No. 40 shows a crack ending in slag and surrounded by decarbonized iron. The course of the slag was quite irregular, as shown in photographs Nos. 41 and 42.

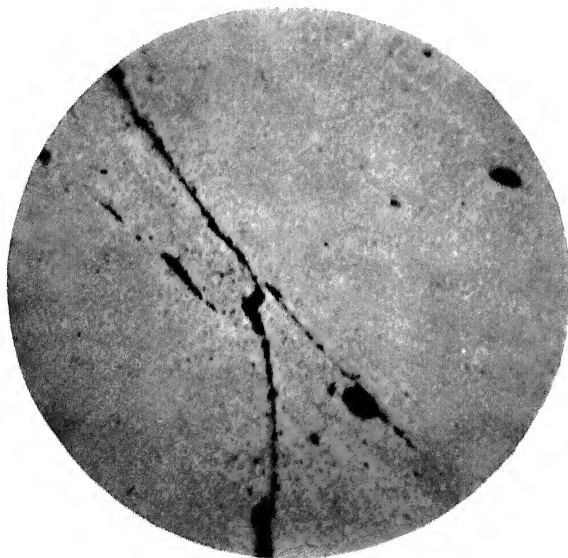
PHOTOGRAPH NO. 41. X50.

Slag in 10-inch rifle, unetched.

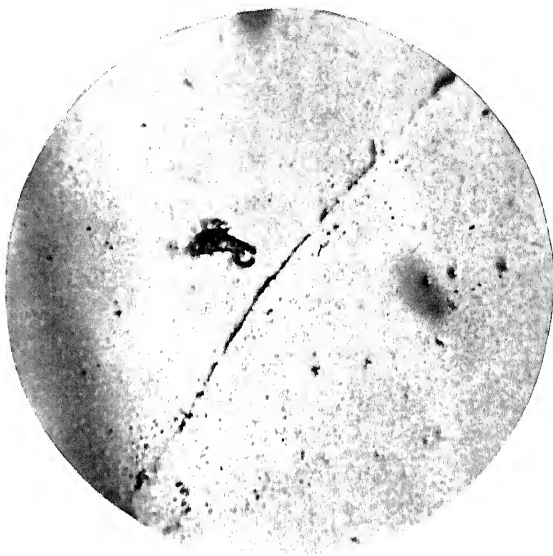
PHOTOGRAPH NO. 42. X50.

Slag in 10-inch rifle, unetched.

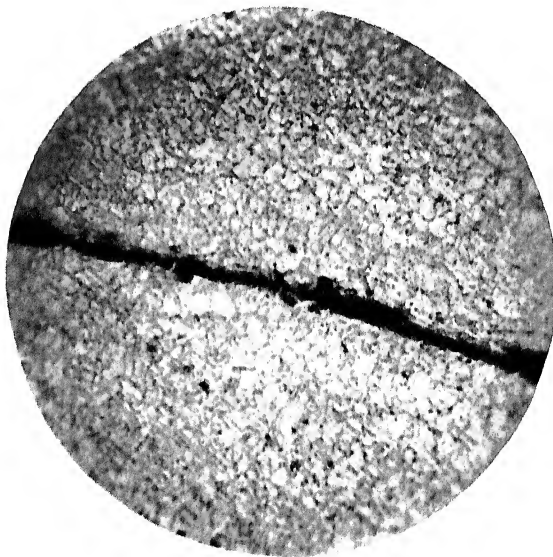
PHOTOGRAPH NO. 43. X50.

Slag and decarbonized area in 10-inch rifle.

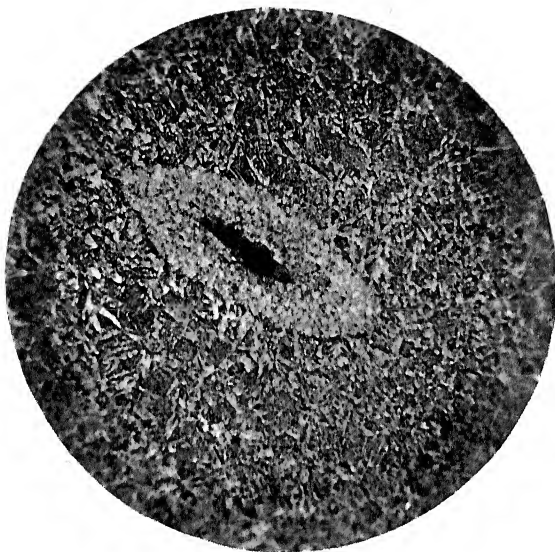
PHOTOGRAPH NO. 44. X50.

Island of slag in decarbonized area in 10-inch rifle.

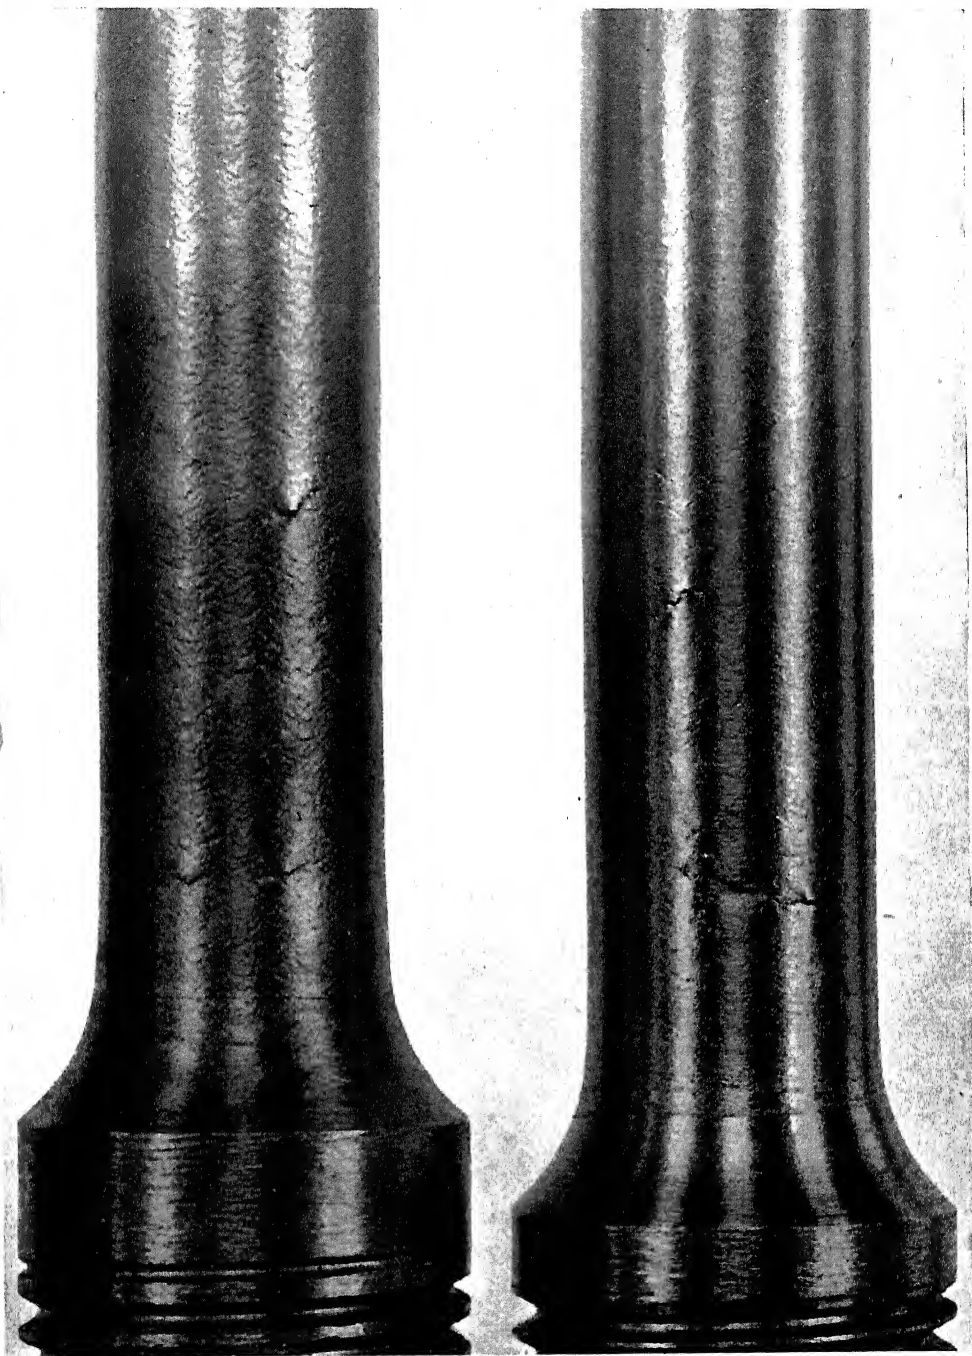
PHOTOGRAPH NO. 45.

Fourteen-inch gun lever test bar specimens showing incipient cracks.

In the fractured ends of the test pieces the metal shows decidedly bright spots, and these are due, it is believed, to the presence of the segregated ferrite. Further, it has been noticed that along the stem of the test pieces incipient cracks are developed, as shown in photograph No. 45. It is highly probable that these incipient fractures are developed in such areas as shown in photograph No. 47, which shows a large ferrite field at the edge of the specimen. It is possible that if the forces are transmitted equally throughout the test piece that such a portion would yield more readily where the carbon was lowest. The strength of such a spot would be approximately that of pure iron, or about 40,000 pounds per square inch, while the darker areas which contain more carbon would show considerably higher values. The presence of much slag in the ferrite areas would also increase the brittleness at this point, and would account for the low ductility in some specimens. Further examples of this form of segregation are shown in photographs Nos. 48 and 49.

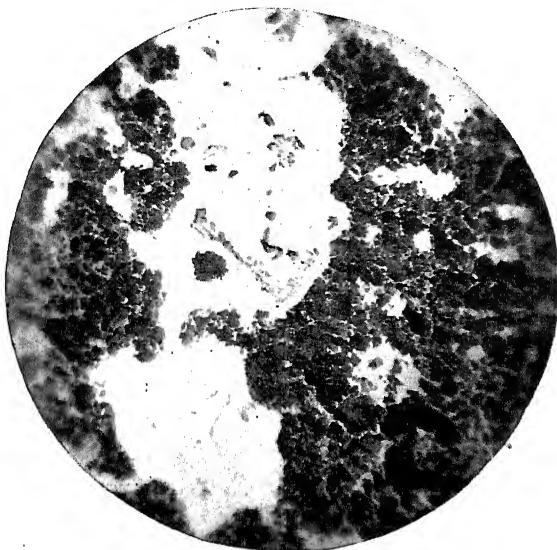
PHOTOGRAPH NO. 46. X50.

Fourteen-inch gun lever. Segregated ferrite (white) with slag inclusions.

This lever was made of cast steel and was broken during the test of the carriage. A microscopic examination revealed the structures shown in photographs Nos. 46 to 51, inclusive.

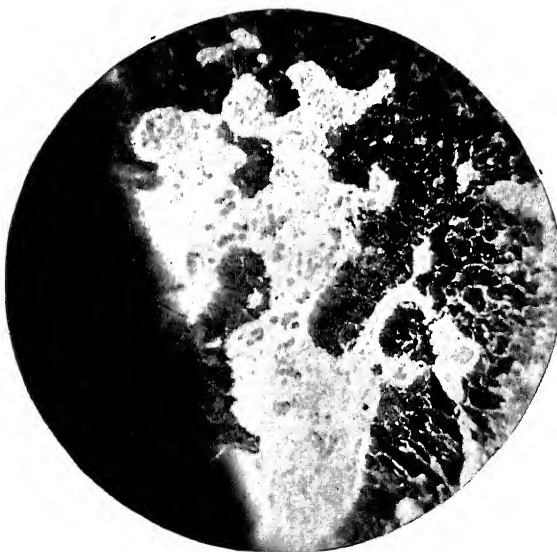
PHOTOGRAPH NO. 47. X50.

Fourteen-inch gun lever. Segregated ferrite on edge of test piece. Slag inclusions.

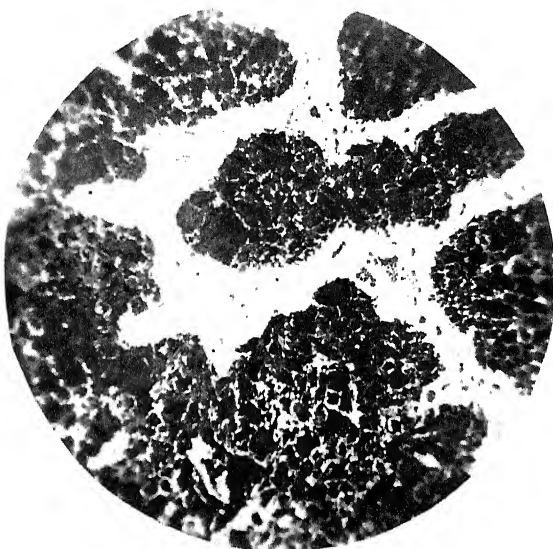
PHOTOGRAPH NO. 48. X50.

Fourteen-inch gun lever. Segregated ferrite (white) with slag inclusions.

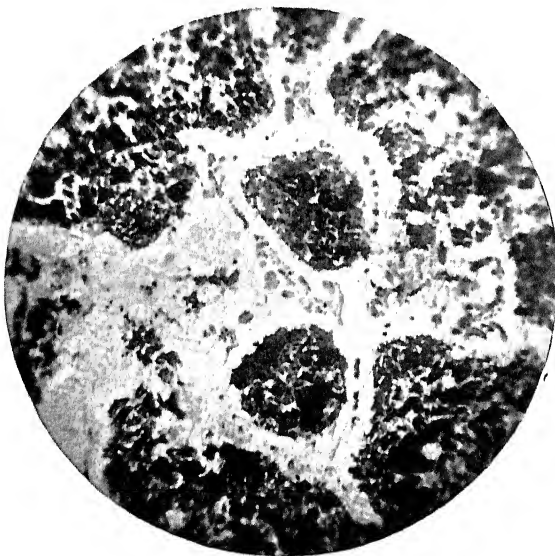
PHOTOGRAPH NO. 49. X50.

Fourteen-inch gun lever. Segregated ferrite with slag inclusions.

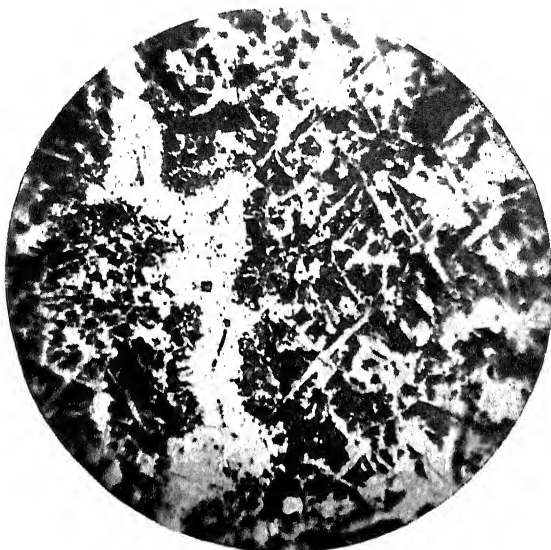
PHOTOGRAPH NO. 50. X50.

Fourteen-inch gun lever. Segregated ferrite and crystalline structure.

The metal has not been annealed in such a way as to remove the original crystallization which took place at the time of solidification. The crystalline structure is shown in photographs Nos. 50 and 51. Proper annealing should have completely wiped out all appearance of this kind. Evidence of this crystalline nature was found in all specimens examined, and it is highly
